**Flood Control Project Maintenance
Levee Inspections**

Maintenance Issue Types Only, Levee Inspection Report By Mile - Fall 2015

Reclamation District No. 2085 Kasson

Waterway	Bank	Unit Miles	Inspection Start/End	Inspector
Unit No. 01 San Joaquin River	Left	5.29	11/10/2015 11/10/2015	Maksim Khashchuk

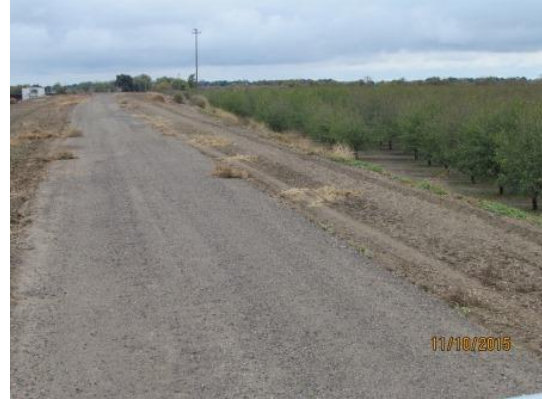
Photo 1 of 1 : FA_2015_RD2085_113_19_20151112_00019.jpg

LM Start	0.12	Rating **	M	Issue No.	19
LM End	0.12	Issue Type +	Ma	Location *	CR
Category	Earthen Levee			GPS Latitude/Longitude	
				Start	End
Item	Crown Surface / Depressions / Rutting			37.719052 °	37.719052 °
				-121.302928 °	-121.302928 °
DWR ID	DWR_RD2085_01_f_2015_19				
Action/Comments					
Add appropriate material and re-grade the levee to bring the crown above the design elevation. Inspector Comments: Disking on the levee shoulder.

View of the diskings on the levee crown shoulder.

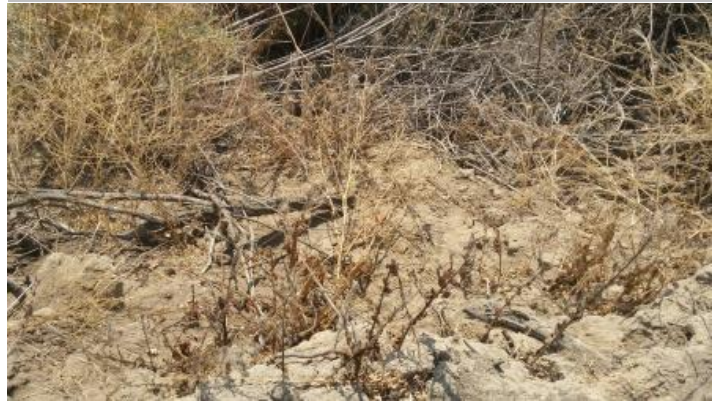
Photo 1 of 2 : SJR2015_RD2085U01RM66.50_11.jpg

121.274894 °	121.274894 °
DWR ID					
Action/Comments					
Inspector Comments: 09/10/2015: No significant change observed. Signs of animal activity are present. 09/10/2014: No significant change observed. 09/20/2013: No significant change in erosion observed. More vegetation at the site. 12/04/2012: The erosion has progressed remarkably toward levee, extended to the up-and downstream of the original pocket erosion. Trees and dense bush are present at the site. Animal burrow holes are visible, and possibly can cause seepage. 09/22/2010: No significant change observed. There is little visibility due to seasonal grass on the berm and slope. 08/18/2009: Site is located on berm; pocket erosion has developed; the site is covered in dense vegetation; there are several relief wells on the landside of the levee; site is Not Rated because berm width is greater than 30 feet; site should be monitored to keep track of erosion progress. [2015 Site ID:RD2085U01RM66.5]

Direct view of the erosion. Note dense vegetation at the site.

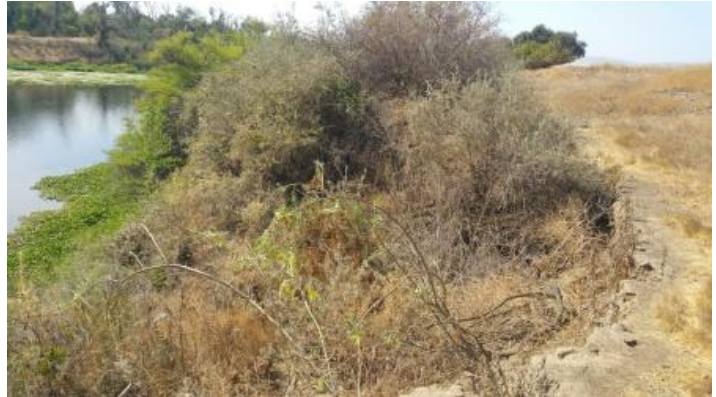
Photo 2 of 2 : SJR2015_RD2085U01RM66.50_4.jpg

121.274894 °	121.274894 °
DWR ID					
Action/Comments					
Inspector Comments: 09/10/2015: No significant change observed. Signs of animal activity are present. 09/10/2014: No significant change observed. 09/20/2013: No significant change in erosion observed. More vegetation at the site. 12/04/2012: The erosion has progressed remarkably toward levee, extended to the up-and downstream of the original pocket erosion. Trees and dense bush are present at the site. Animal burrow holes are visible, and possibly can cause seepage. 09/22/2010: No significant change observed. There is little visibility due to seasonal grass on the berm and slope. 08/18/2009: Site is located on berm; pocket erosion has developed; the site is covered in dense vegetation; there are several relief wells on the landside of the levee; site is Not Rated because berm width is greater than 30 feet; site should be monitored to keep track of erosion progress. [2015 Site ID:RD2085U01RM66.5]

Close view of the erosion.

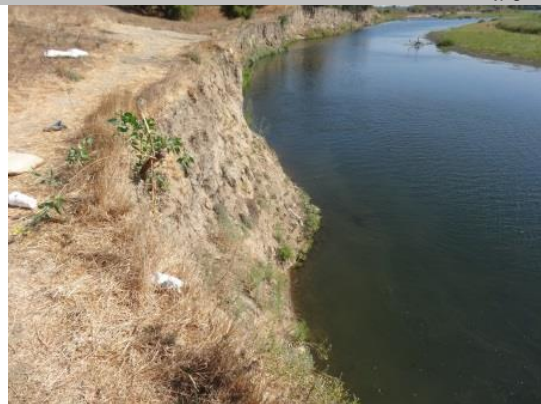
Photo 1 of 2 : SJR2015_RD2085U01RM67.70_4.jpg

LM Start	3.62	Rating **	A/W	Issue No.	2
LM End	3.75	Issue Type +	Ma	Location *	WS
Category	Supplemental			GPS Latitude/Longitude	
				Start	End
Item	DWR Erosion Survey			37.688545 °	37.688545 °
				-121.276298 °	-121.276298 °
DWR ID					
Action/Comments					
Inspector Comments: 08/19/2015: No significant change observed. 7/17/2014: No significant change observed. 09/10/2013: No significant change observed. 12/04/2012: This site has been documented before, and a cost estimate to repair has been prepared dated 05/09/2010. The fresh cut shows the erosion is developing. The berm width is at least 42 feet. Sticks were placed at three locations along the river bank, with 3 sticks 5 feet apart at each location. [2015 Site ID:RD2085U01RM67.7]

Close view of the erosion.

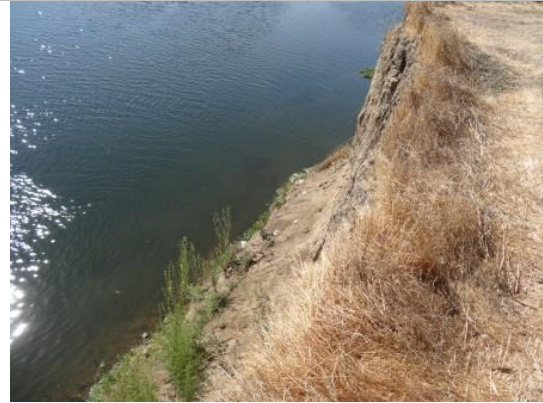
Photo 2 of 2 : SJR2015_RD2085U01RM67.70_9.jpg

LM Start	3.62	Rating **	A/W	Issue No.	2 (cont)
LM End	3.75	Issue Type +	Ma	Location *	WS
Category	Supplemental			GPS Latitude/Longitude	
				Start	End
Item	DWR Erosion Survey			37.688545 °	37.688545 °
				-121.276298 °	-121.276298 °
DWR ID					
Action/Comments					
Inspector Comments: 08/19/2015: No significant change observed. 7/17/2014: No significant change observed. 09/10/2013: No significant change observed. 12/04/2012: This site has been documented before, and a cost estimate to repair has been prepared dated 05/09/2010. The fresh cut shows the erosion is developing. The berm width is at least 42 feet. Sticks were placed at three locations along the river bank, with 3 sticks 5 feet apart at each location. [2015 Site ID:RD2085U01RM67.7]

Direct view of the erosion.

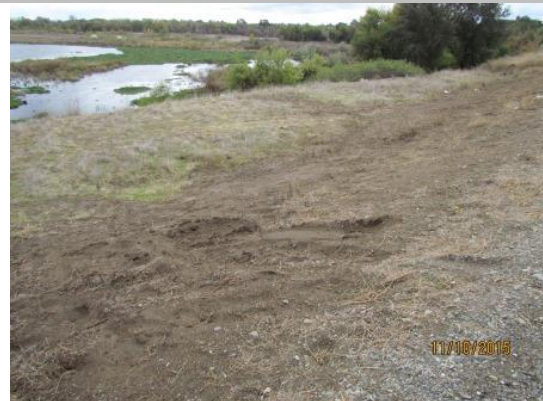
Photo 1 of 1 : FA_2015_RD2085_113_25_20151112_00020.jpg

View of the waterside levee slope damaged by vehicle.

LM Start	3.71	Rating **	M	Issue No.	25
LM End	3.71	Issue Type +	Ma	Location *	WS
Category	Earthen Levee			GPS Latitude/Longitude	
				Start	End
Item	Slope Stability			37.688216 °	37.688216 °
				-121.276603 °	-121.276603 °
DWR ID	DWR_RD2085_01_f_2015_25				
Action/Comments					
Repair the levee slope damaged by vehicle traffic and prevent access where possible.

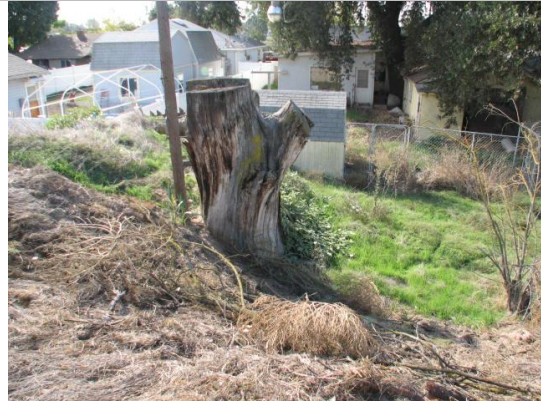
Photo 1 of 1 : FA_2015_RD2085_113_32_20150910_00006.jpg

LM Start	4.46	Rating **	N	Issue No.	32
LM End	4.46	Issue Type +	Ma	Location *	LS
Category	Earthen Levee			GPS Latitude/Longitude	
				Start	End
Item	Trim / Thin Trees			37.681605 °	37.681605 °
				-121.268882 °	-121.268882 °
DWR ID	DWR_RD2085_01_s_2012_32				
Action/Comments					
Tree stumps.

11/03/2011 Large stump on landside slope.

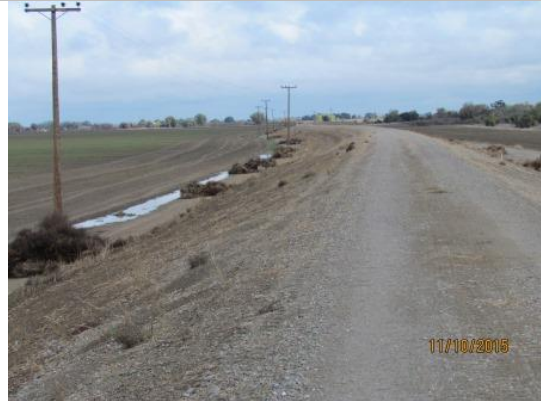
Photo 1 of 1 : FA_2015_RD2085_114_4_20151112_00003.jpg

View of the acceptable vegetation control on the waterside levee slope.

LM Start	0.07	Rating **	A	Issue No.	4
LM End	0.07	Issue Type +	Ma	Location *	WS
Category	Earthen Levee			GPS Latitude/Longitude	
				Start	End
Item	Vegetation			37.705740 °	37.705740 °
				-121.274151 °	-121.274151 °
DWR ID	DWR_RD2085_02_f _ 2015_4				
Action/Comments					
Control annual grass and weeds on the levee slopes and easements.

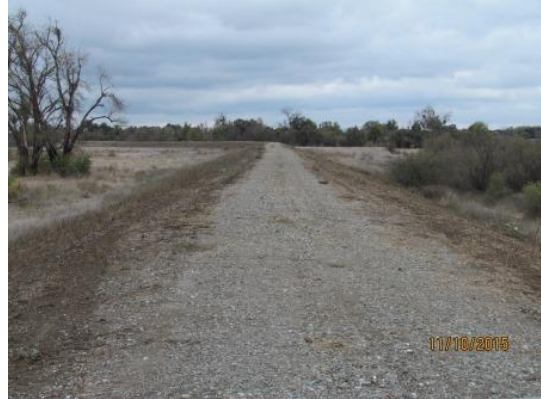
Photo 1 of 1 : FA_2015_RD2085_115_4_20151112_00003.jpg

View of the acceptable vegetation control on the waterside levee slope.

LM Start	0.02	Rating **	A	Issue No.	4
LM End	0.02	Issue Type +	Ma	Location *	WS
Category	Earthen Levee			GPS Latitude/Longitude	
				Start	End
Item	Vegetation			37.680772 °	37.680772 °
				-121.264359 °	-121.264359 °
DWR ID	DWR_RD2085_03_s_2015_4				
Action/Comments					
Remove the wild growth other than native grasses from the levee slopes.

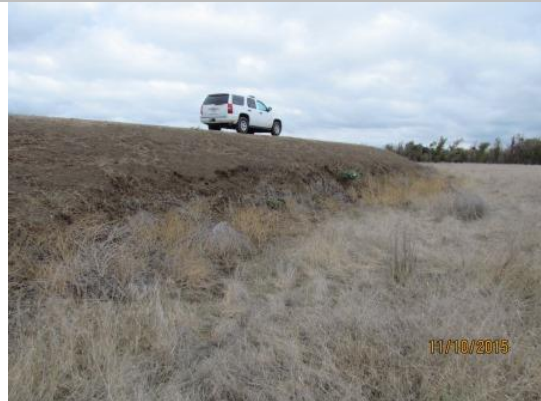
Photo 1 of 1 : FA_2015_RD2085_115_1_20151112_00004.jpg

LM Start	0.21	Rating **	U	Issue No.	1
LM End	0.23	Issue Type +	Ma	Location *	WS
Category	Earthen Levee			GPS Latitude/Longitude	
				Start	End
Item	Erosion / Bank Caving			37.682798 °	37.683052 °
				-121.262059 °	-121.261851 °
DWR ID	DWR_RD2085_03_s_2014_1				
Action/Comments					
Schedule repair of erosion site prior to the next inspection. Inspector Comments: Erosion of the waterside levee slope has been observed. The erosion is about 3 feet tall vertical from the slope to the base of projected levee toe.

View of the erosion at the waterside levee toe.
